# TMK Consulting Engineers

TMK Ref. 2202023\_R1 | 16 March 2022

## STRUCTURAL ASSESSMENT

(BRIDGE) TWENTY FIRST STREET, RENMARK.

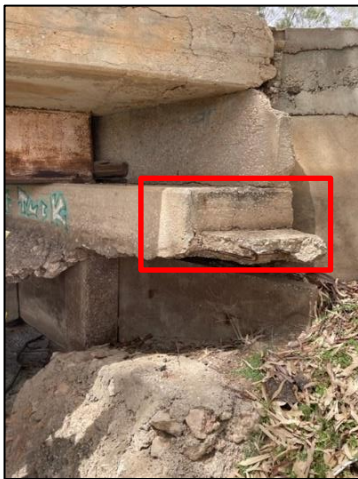
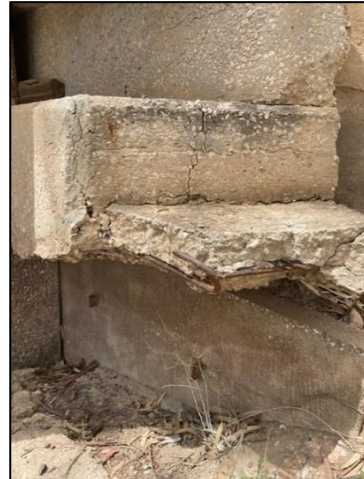
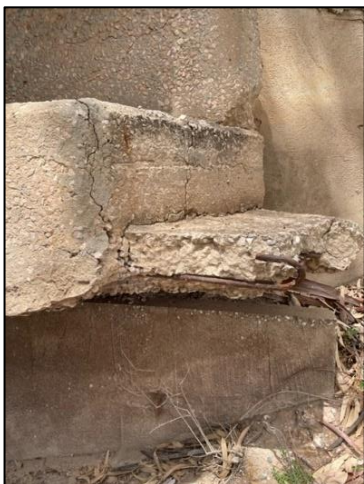
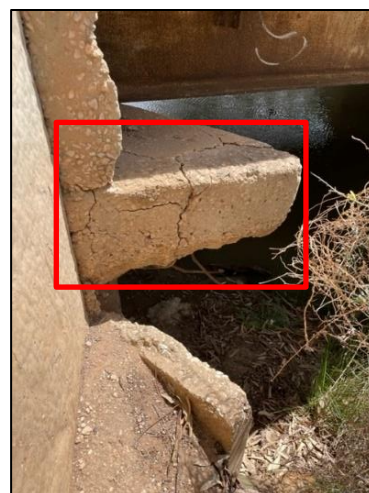
- A. Concrete degradation and spalling occurring to both ends of the concrete support beam to east embankment, exposing internal steel reinforcement. Location indicated as per figures 2 – 5.
- B. Concrete repair and reinstatement required to encase the currently exposed steel reinforcement constituent of the concrete support beam.
- C. Recommended Scope;
  - Provide well scabbled surface and remove loose material
  - Apply surface preparation adhesive product as outlined in Concrete Repair Procedure. Refer to section 2.1.3 (F).
  - Box up formwork to suit existing dimensions of concrete beam. Ensure minimum concrete cover of 50mm throughout.
  - Ensure new concrete encases exposed reinforcement.

**Photo 2 – Concrete degradation showing exposed reinforcement of concrete support beam on East end of bridge.**

**Photo 3 – Concrete degradation showing exposed reinforcement of concrete support beam on East end of bridge.**

**Photo 4 – Concrete degradation showing exposed reinforcement of concrete support beam on East end of bridge.**

**Photo 5 – Concrete degradation showing exposed reinforcement of concrete support beam on East end of bridge.**

2.1.2	<b>REINFORCED CONCRETE END SUPPORT BEAMS (660 X 455mm REINFORCED CONCRETE BEAMS)</b>										
1	Deteriorated ends of concrete support beam	East end of bridge	Exposed internal reinforcement of concrete support beams at each end due to deteriorations.	3	Removal of all loose materials, with the preparation of surface and existing reinforcement as per the recommended concrete repair procedure (CRP). Following the completion of preparation, formwork is required to reinstate and encase the existing reinforcement.	R&M	1	\$2,500.00

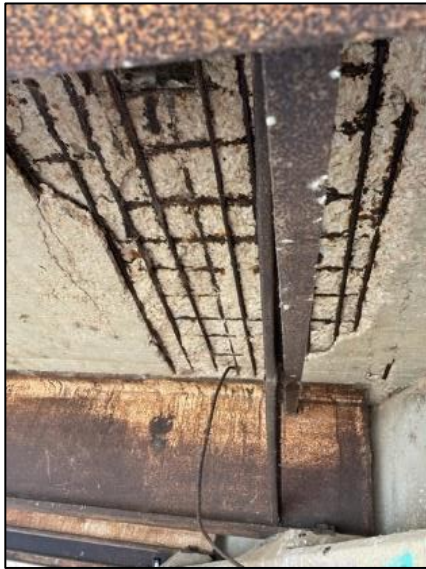
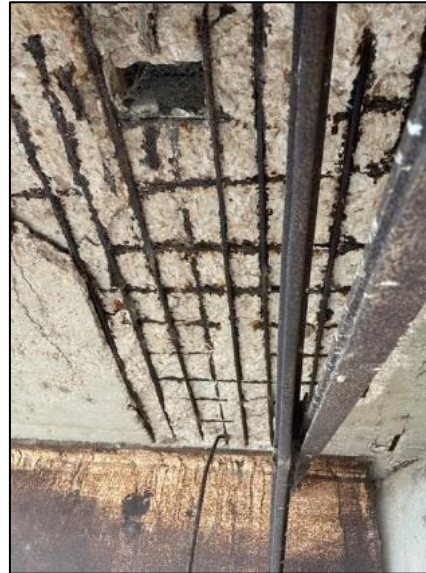
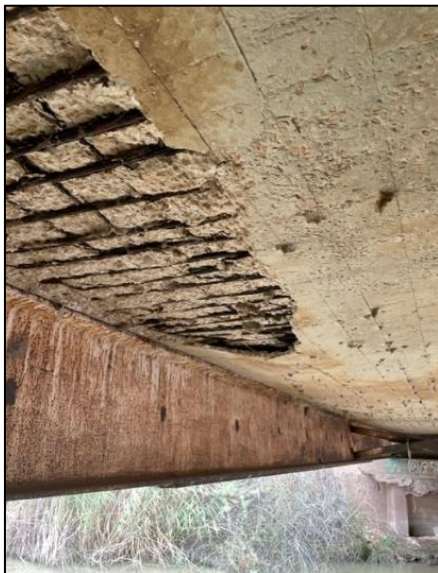
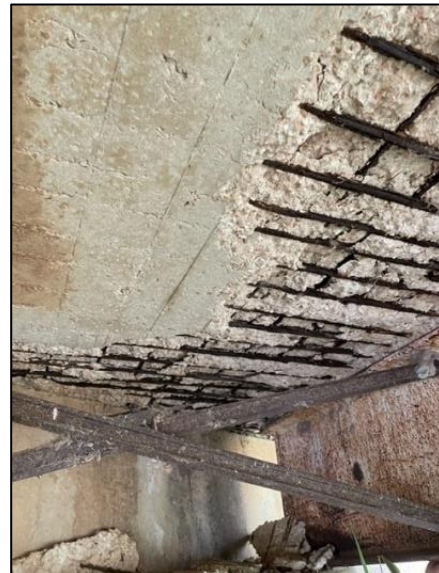
- A. Concrete delamination and spalling occurring, exposing corroded reinforcement on both the east and west ends of the bridge. Area of concrete degradation requiring remedial works determined upon initial site investigation is approximately 25m<sup>2</sup>. Further carbonation and “tap” testing required onsite, when remedial works are to take place in order to accurately determine full extent of substrate affected by carbonation. Locations indicated as per figures 6 – 9.
- B. Exposed reinforcement requires cleaning and stripping of all corroded and loose materials, in order to determine full extent of sectional losses. If it is determined that level of reinforcement corrosion exceeds an adequately acceptable limit of 20 percent, installation of additional reinforcement may be required throughout the concrete remediation process.

**Photo 6 – Concrete delamination and spalling from bridge soffit on east end.**

**Photo 7 – Concrete delamination and spalling from bridge soffit on east end.**

**Photo 8– Concrete delamination and spalling from bridge soffit on west end.**

**Photo 9 – Concrete delamination and spalling from bridge soffit on west end.**

- C. Concrete spalling was caused by the expansion of internal reinforcement, and could be attributed to a combination of processes known as ‘**concrete carbonation**’ and **moisture ingress**.

- Saw cut or cut back the perimeter of the repair area to 10mm deep maximum to avoid feather-edging and to provide a clean square edge. Break out the complete repair area to a minimum depth of 10mm up to the sawn edge and 50mm minimum beyond any visible signs of corroding reinforcement or embedded steelwork.
- Clean concrete surfaces and remove any dust, unsound or contaminated material, plaster, oil, paint, grease, corrosion deposits or algae. Where break out is not required, roughen the surface and remove any laitance by light scabbling or abrasive-blasting.

- Steelwork must be clean and free of scale or rust. Remove any contaminants and coatings to achieve a Class 2.5 'very thorough' / 'near white' surface finish to AS 1627.4. (Note: An adequate surface finish is achievable with the use of hand tools; e.g. grinder or wire brush).

4. Prime reinforcement and concrete with MasterEmaco P 5000 AP or similar approved.
5. Apply MasterEmaco S 5300CI or similar approved.

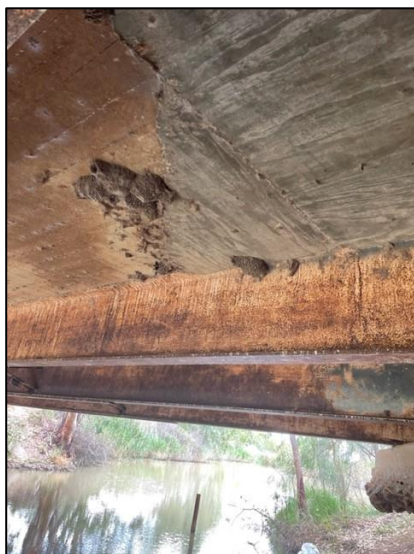
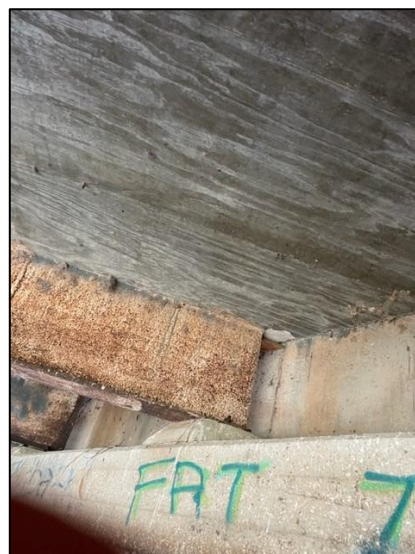
- D. Previously completed repair works were undertaken on the west end of bridge soffit due to pre-existing spalling and concrete degradation. It should be noted that the date of which repairs were conducted, extent of remediation (including the process undertaken and products used during these remedial works) is unknown to this office. Location indicated as per figures 10 - 11.
- E. Previously completed concrete slab soffit repairs were visually inspected by TMK at the time of inspection and no signs of further degradation at the indicated location were evident.

**Photo 10 – Prior completed repairs (East end of bridge)**

**Photo 11 – Prior completed repairs (East end of bridge)**

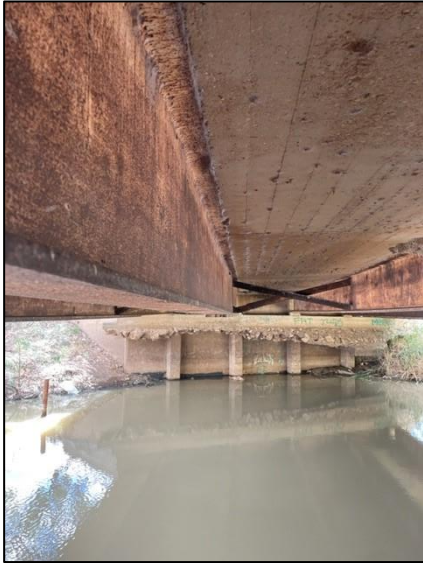
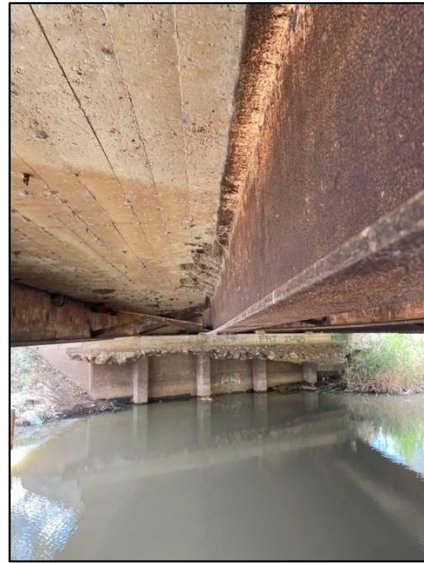
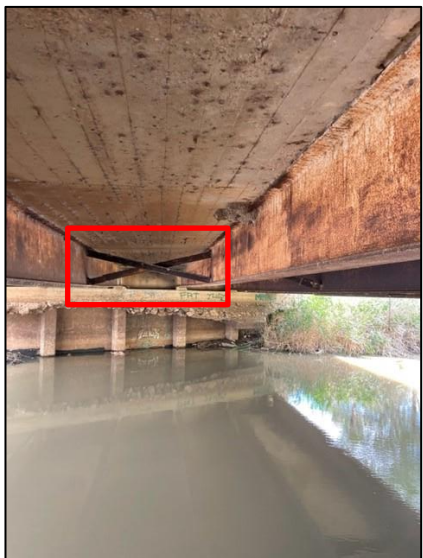
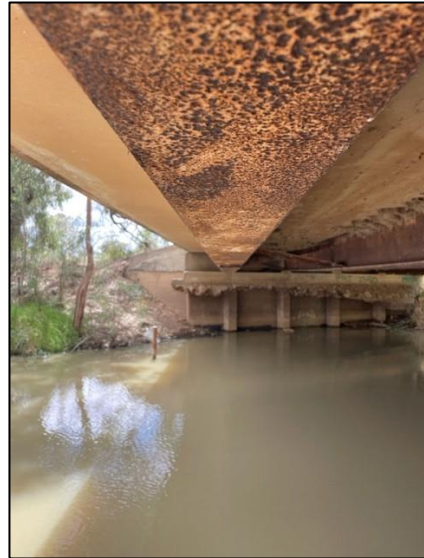
- A. Upon TMK's site investigation, it was determined the primary structural steel beams presented minor levels of corrosion associated with negligible section loss, as indicated in figures 12 – 15.
- B. Steel beams displayed minor signs of torsion buckling, (beams 2 and 4. Locations as per figure 12. (Steel beam numbers determined in order facing west end of bridge).
- C. Upon review of the original structural design documentation of the bridge, followed by the onsite investigation conducted by TMK, indicated in figure 13, it can be seen that cross bracing has been installed to mitigate the effects of torsion buckling throughout the steel beams. As part of the remedial process and scope of works, it is recommended by this office to install additional cross bracing (100x100x12 EA – Hot Dipped Galvanised) in order to control the risk of further torsion buckling.

**Photo 12 – Steel beam #2 displaying minimal torsion buckling (bottom flange showing minor curvature)**

**Photo 13 – Steel beam #2 displaying minimal torsion buckling (bottom flange showing minor curvature)**

**Photo 14 – Steel beam #4 displaying minimal torsion buckling (bottom flange showing minor curvature)**

**Photo 15 – Steel beam condition indicating minor level of corrosion, no sectional losses.**

2.1.4	<b>BRIDGE SUPPORT STEEL BEAMS (5 - 24"x7 1/2" BRITISH STANDARD STEEL BEAMS)</b>							
7	Surface Corrosion	Bridge Soffit	Structural steel framework generally appeared to be in a fair condition with some surface corrosion / dusting. Hence negligible section loss can be concluded	2	Steelwork should be cleaned of surface corrosion and coated with a protective paint system.	R&M	1	\$12,500.00
8	Minor evidence of torsion buckling in steel beam.	Bridge soffit (beams 2 and 4)	visually identified minor evidence of torsion buckling (deflection of bottom flange) of two internal support beams.	2	Installation of additional Equal Angle cross bracing members to mitigate any potential for future buckling effects.(members sizes specified by TMK)	R&M	1	\$10,000.00

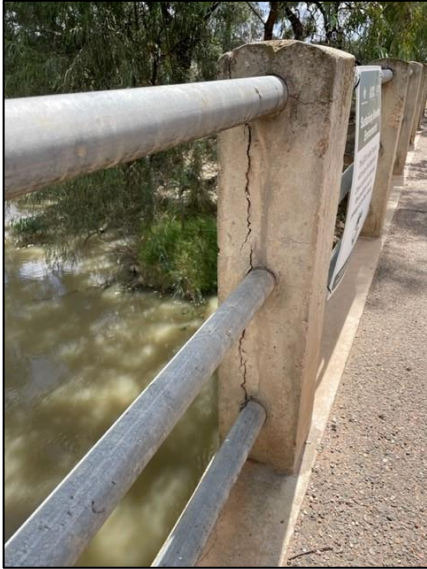
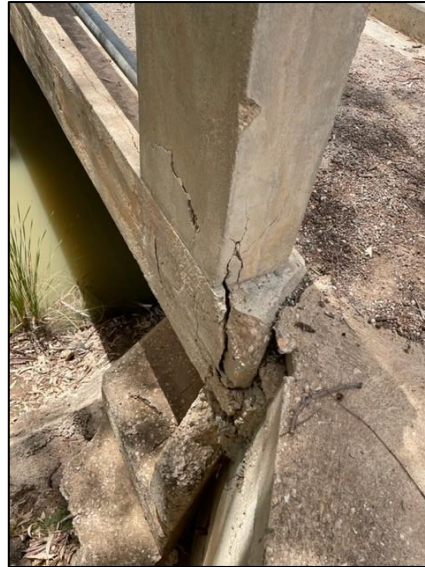
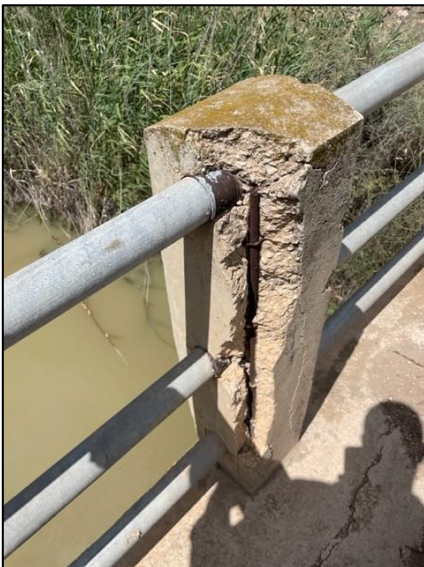
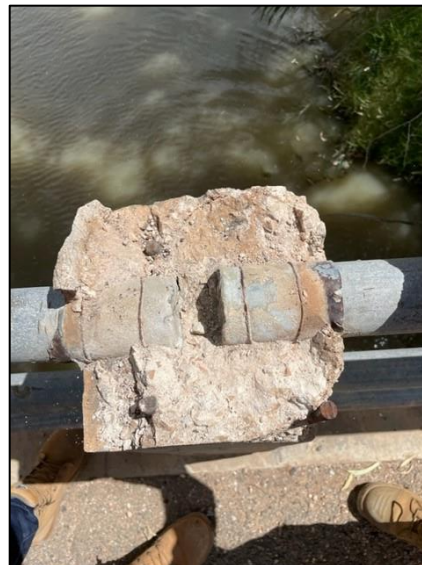
- A. Hand rails on both external perimeters of the bridge were observed during TMK's onsite investigation to have visually evident deterioration and cracking, due to the expansion caused by corrosion of the internal reinforcement of the concrete posts, as indicated in figures 16

- B. It was observed that the hand rail system was not structurally adequate to serve as a vehicular impact barrier, rather just a pedestrian access perimeter barrier.

- C. Based upon site investigation, the extent of damages presented structural significance. It was the considered opinion of this office, that the hand rail system on the foot path side of the bridge was structurally unsafe in its current state and beyond economical repair.

**Photo 16 – Cracked Concrete post of hand rail system.**

**Photo 17 – Evidence of impact damage to concrete post.**

**Photo 18 – Deterioration of concrete post exposing corroded reinforcement**

**Photo 19 – Deterioration of concrete post exposing corroded reinforcement**

- D. Hand rail system appeared to be original from the time of initial construction, it is the advice of this office that full replacement of the hand rail system is required without delay.

2.1.5	<b>BRIDGE PERIMETER HAND RAILS</b>							
9	Concrete Breakout (Removal of Existing Hand Rail System) & Surface Preparation	Bridge deck	Depending on extent of deteriorated concrete cover identified upon removal of concrete posts. Repair may consist of either localised patch repairs or potentially total concrete cover replacement.	4	Recommend to remove existing concrete post and rail perimeter system, followed by the surface preparation of concrete base as per the recommended Concrete Repair Procedure (CRP).	R&M	1	\$3,500.00
10	Perimeter Hand Rail Replacement	Bridge deck (east end)	Hand Rail system to be replaced due to extent of degradation beyond economical repair.	4	Suitable Steel Post and Rail system should be installed as soon as practical following the removal of existing hand rail system.	R&M	1	\$7,500.00

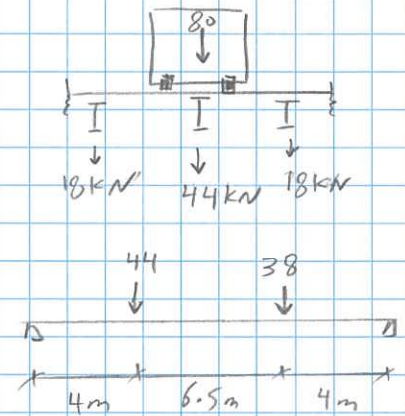
SC-09 →  $\left\{ \begin{array}{l} \text{max compression stress is } 198 > 153 \text{ MPa } \underline{\text{not ok}} \\ \text{max tension stress is } 139 < 153 \text{ MPa } \underline{\text{ok}} \end{array} \right.$

⇒ [15 Tonne bus is not allowed to cross the bridge until further assessment of steel grade (Properties  $f_y, f_u$ ) to be done]

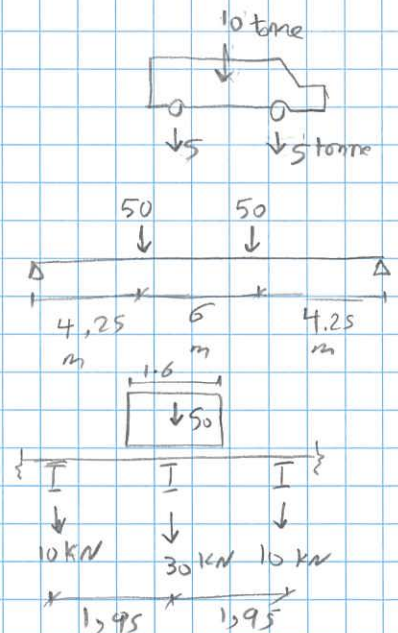
- compression flange 170 MPa  $\approx f_y$

- Tension flange 118 MPa

⇒ [we can accept (10 tonne) vehicle with 5+ axle load at max]
