Level 2 Structure Condition Report (Suggested Form)	Form L2-1
---	------------------

Structure ID	BR001	Road Name	Twentyfirst Street
Bridge Name	Twentyfirst Street Bridge	Road Number	-
Crossing (road or stream)	Stream	Road Class	Local
Structure Type	Road Bridge	Locality/Suburb	Renmark, SA 5341
Construction Type	Abutment, piers, support beams and concrete deck	Map Number	-
		Ref #	-
Construction Material	Concrete	Latitude	-34.173949
Date of Construction	1960	Longitude	140.728693
Date of Inspection	18/05/2023	Local Authority	Renmark Paringa Council

Twentyfirst St Bridge, Renmark

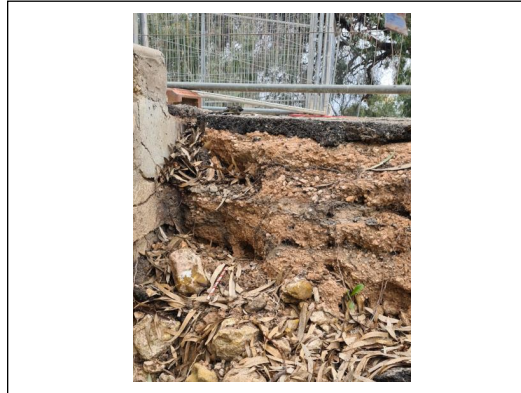
Mod	Group	Component	Condition State
<input type="text" value="O"/>	<input type="text" value="AP1"/>	<input type="text" value="RD"/>	<input type="text" value="3"/>

O		AP	1	RD	1	O	Each	1	2	<input checked="" type="checkbox"/>				1	TMK (Post-Flood) - Floodwaters had caused erosion to base course and subgrade layers beneath the road surface at the abutments – causing loss of portions of the road surface. Tonkin - Road scour and more severe closer to the joint/abutment. Pavement base course and subgrade layers eroded at the road shoulders. Need reinstating.
O		AP	1	BR	2	S	Lm	1	2	<input checked="" type="checkbox"/>				1	TMK (Pre-Flood) - Hand rails on both external perimeters of the bridge were observed during TMK's onsite investigation to have visually evident deterioration and cracking, due to the expansion caused by corrosion of the internal reinforcement of the concrete post. It was observed that the hand rail system was not structurally adequate to serve as a vehicular impact barrier, rather just a pedestrian access perimeter barrier. Tonkin - Signs of severe concrete cracking and deterioration. Steel sections not held together very effectively. Barrier deemed inadequate to absorb significant vehicle impact. Corrosion of the internal reinforcement in the concrete posts have caused cracking at the edge of the deck. A steel section is missing between the first two concrete posts.

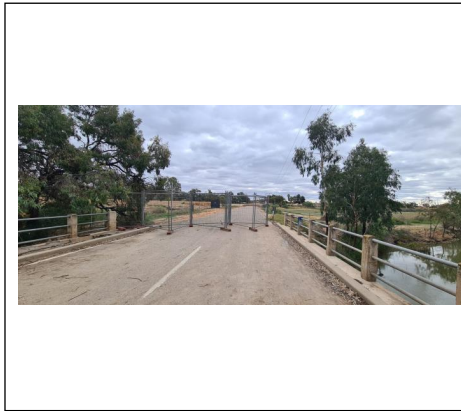
Mod	Group	Component	Condition State
<input type="text" value="O"/>	<input type="text" value="S"/>	<input type="text" value="WS"/>	<input type="text" value="2"/>

O		S	1	WS	1	O	m ²	113	2	<input type="checkbox"/>	96	17		TMK (Post-Flood) - The roadway was visually less affected but possible delamination of the road surface cannot be excluded. Tonkin - Generally in good condition with no severe cracking at the surface of the pavement layer.	
O		S	1	K	1	C	Lm	15	2	<input type="checkbox"/>	15			Tonkin - New kerb installed with the level raised compared to the original drawing. The kerb is in relatively good condition with no cracking or spalling.	
O		S	1	W	1	O	Each	1	2	<input type="checkbox"/>	1			Tonkin - Waterway is clear with no significant obstructions that would impede the water flow.	
O		S	1	FY	1	C	Lm	15	2	<input checked="" type="checkbox"/>				15	TMK (Post-Flood) - The asphalted pedestrian walkway on the north-western side of the bridge had been severely eroded and delaminated from the bridge deck due to floodwater activity. Tonkin - Resurfacing of the pathway. Significant cracking and deterioration of the asphalt layer and gravel underneath.

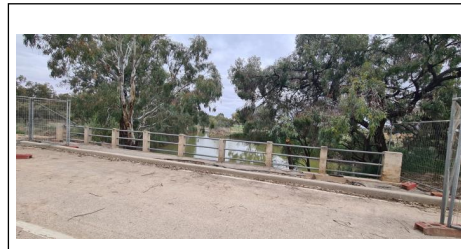
Mod	Group	Component	Condition State
O	S	BR2	4

O		S	1	BR	2	S	Lm	15	2	<input checked="" type="checkbox"/>				15	TMK (Pre-Flood) - Hand rails on both external perimeters of the bridge were observed during TMK's onsite investigation to have visually evident deterioration and cracking, due to the expansion caused by corrosion of the internal reinforcement of the concrete post. It was observed that the hand rail system was not structurally adequate to serve as a vehicular impact barrier, rather just a pedestrian access perimeter barrier. Tonkin - Signs of severe concrete cracking and deterioration. Steel sections not held together very effectively. Barrier deemed inadequate to absorb significant vehicle impact. Corrosion of the internal reinforcement in the concrete posts have caused cracking at the edge of the deck. Concrete posts are smaller in size compared to the end posts on both sides.

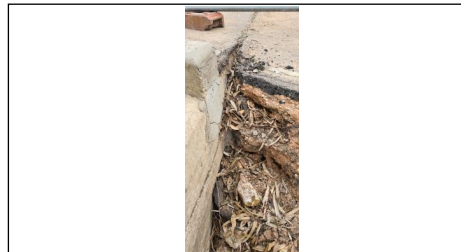
Mod	Group	Component	Condition State
O	AP2	RD	3

O		AP	2	RD	1	O	Each	1	2	<input checked="" type="checkbox"/>				1	TMK (Post-Flood) - Floodwaters had caused erosion to base course and subgrade layers beneath the road surface at the abutments – causing loss of portions of the road surface. Tonkin - Road scour and more severe closer to the joint/abutment. Pavement base course and subgrade layers eroded at the road shoulders. Need reinstating.
O		AP	2	BR	2	S	Each	1	2	<input checked="" type="checkbox"/>				1	TMK (Pre-Flood) - Hand rails on both external perimeters of the bridge were observed during TMK's onsite investigation to have visually evident deterioration and cracking, due to the expansion caused by corrosion of the internal reinforcement of the concrete post. It was observed that the hand rail system was not structurally adequate to serve as a vehicular impact barrier, rather just a pedestrian access perimeter barrier. Tonkin - Signs of severe concrete cracking and deterioration. Steel sections not held together very effectively. Barrier deemed inadequate to absorb significant vehicle impact. Corrosion of the internal reinforcement in the concrete posts have caused cracking at the edge of the deck.

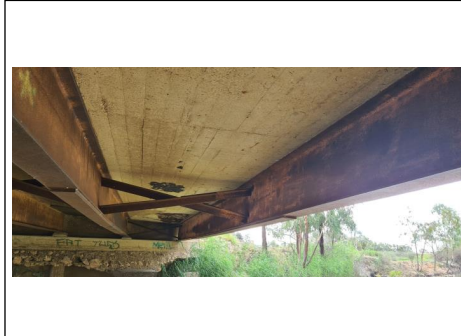
Report Image No. 16 Date 18/05/2023
 Original Image No. Twentyfirst St Bridge (16).jpg
 Mod O Group S Component D Condition State 3

O		S	1	D	1	C	Each	1	2	<input checked="" type="checkbox"/>			1		TMK (Post-Flood) - Minor additional spalling of concrete was noted – likely loose concrete fragments being removed by floodwater activity. Around 150mm rubble on top of the deck as part of resurfacing which is adding extra dead load. Minimal cover underneath the bridge deck causing concrete delamination and exposing of the bottom steel reinforcement. Concrete patch repair works have been done but in isolated section only. Honeycombing possibly due to inadequate compacting.
O		A	1	B	1	O	Each	5	2	<input checked="" type="checkbox"/>			3	2	TMK (Post-Flood) - Grouted end bearings of the steel beams had been eroded due to historic cracking and floodwater activity. Tonkin - Bearing showing typical signs of fatigue and distortion due to flooding. Steel plate and bolts have corroded.
O		A	1	WW	1	C	Each	2	2	<input checked="" type="checkbox"/>			2		Tonkin - Newer concrete. Pre-cast section installed post initial construction.

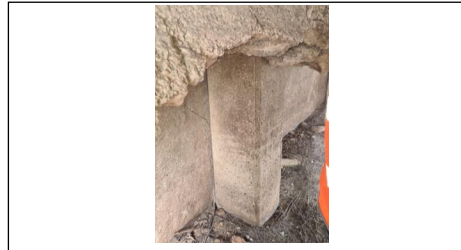
Mod	Group	Component	Condition State
O	A1	P	2

O		A	1	P	1	C	Each	5	2	<input type="checkbox"/>			5		TMK (Post-Flood) - No signs of significant differential movement were observed during the non-destructive investigation, to the concrete piers. Tonkin - concrete piles are relatively more intact and no sign of differential movement observed.
O		A	1	H	1	C	Each	1	2	<input checked="" type="checkbox"/>			1		TMK (Pre-Flood) - Concrete degradation and spalling occurring to both ends of the concrete support beam to east embankment, exposing internal steel reinforcement. Tonkin - As per the tap test, the concrete deemed gummy or corroded. No longer fulfilling structural purpose.
O		A	1	A	1	C	m ²	18	2	<input checked="" type="checkbox"/>			18		TMK (Post-Flood) - The bridge abutments had suffered erosion effects from the floodwater. Tonkin - Isolated cracks observed that go across the abutment. There appears to be multiple stages of reconstruction/repair over the life-span of the bridge with pre-cast concrete wall installation and pouring concrete.
