TMK Ref. 2202023\_R2 | 24 FEBRUARY 2023

## STRUCTURAL ASSESSMENT

(BRIDGE) TWENTYFIRST STREET, RENMARK.

**RENMARK PARINGA COUNCIL**

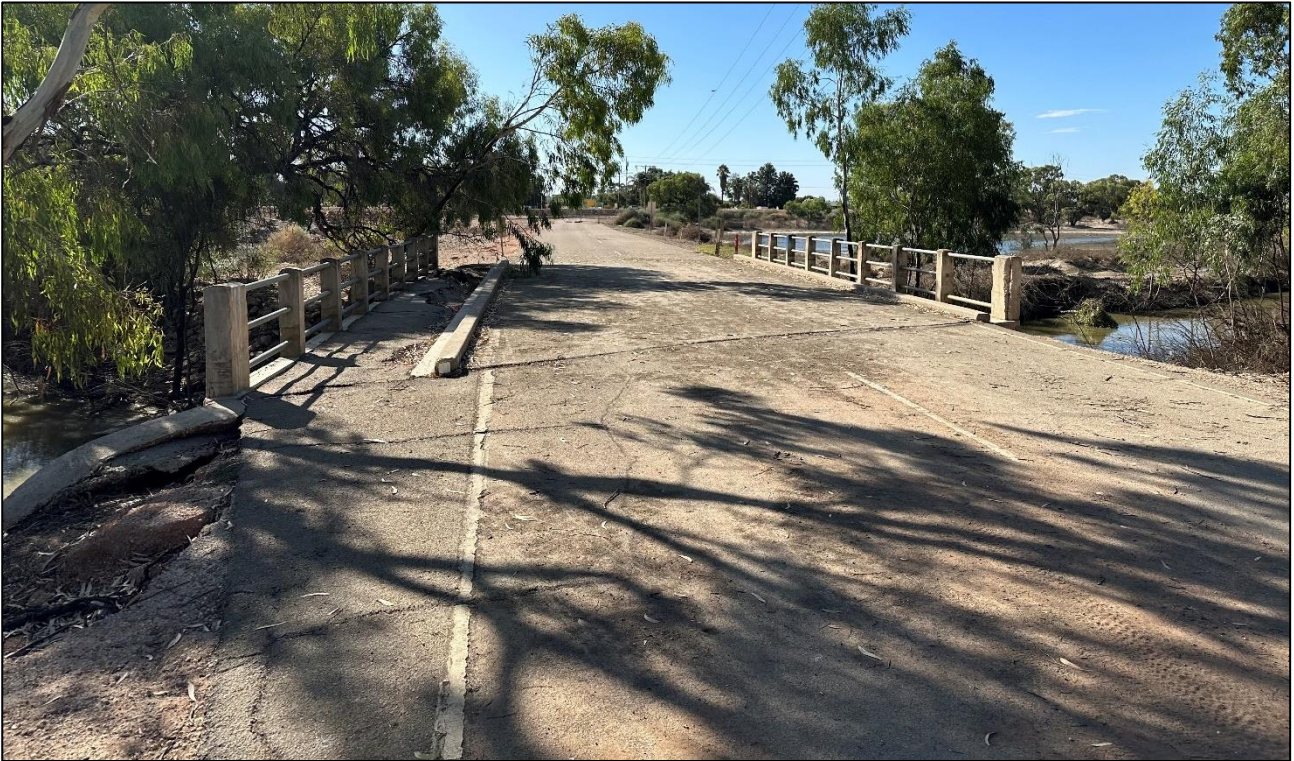
The road surfaces to each of the bridge approaches had suffered minor subsidence which was evident due to parallel cracks in the asphalt road surfaces and level difference in the road surface immediately prior to the bridge.

**Photo 1 - Cracking and subsidence to road surface at the bridge approach**

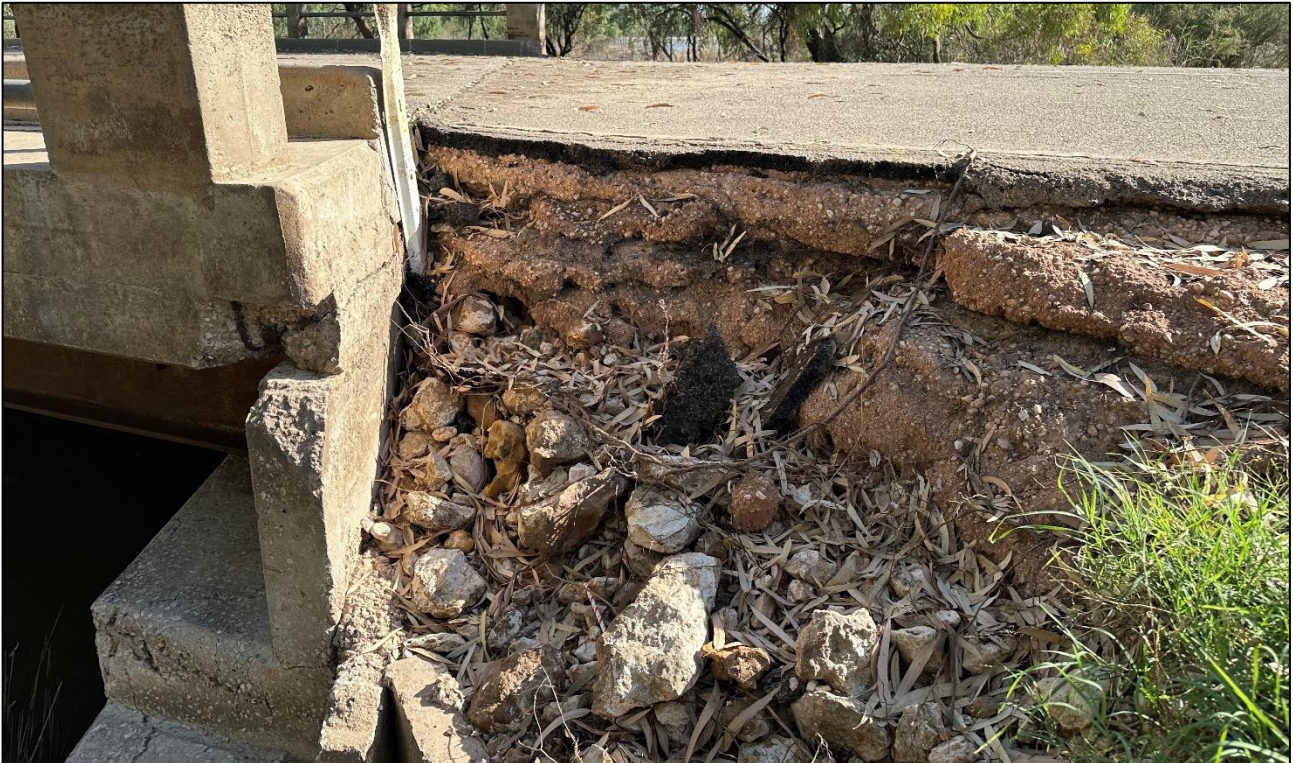
The bridge abutments had suffered erosion effects from the floodwater. Floodwaters had caused erosion to base course and subgrade layers beneath the road surface at the abutments – causing loss of portions of the road surface.

**Photo 2 - Erosion of road layers**

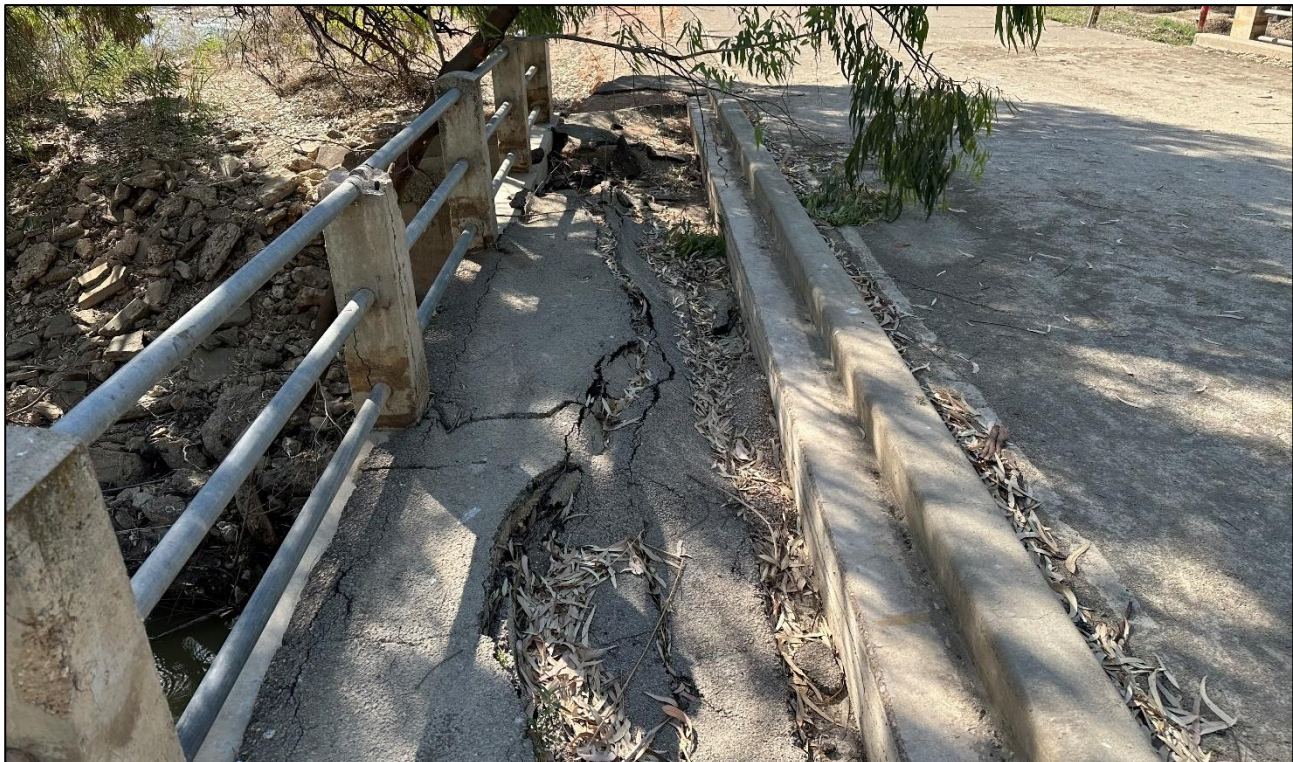
The asphalted pedestrian walkway on the north-western side of the bridge had been severely eroded and delaminated from the bridge deck due to floodwater activity.

The roadway was visually less affected but possible delamination of the road surface cannot be excluded.

**Photo 3 – Severe deterioration & erosion of pedestrian footpath**

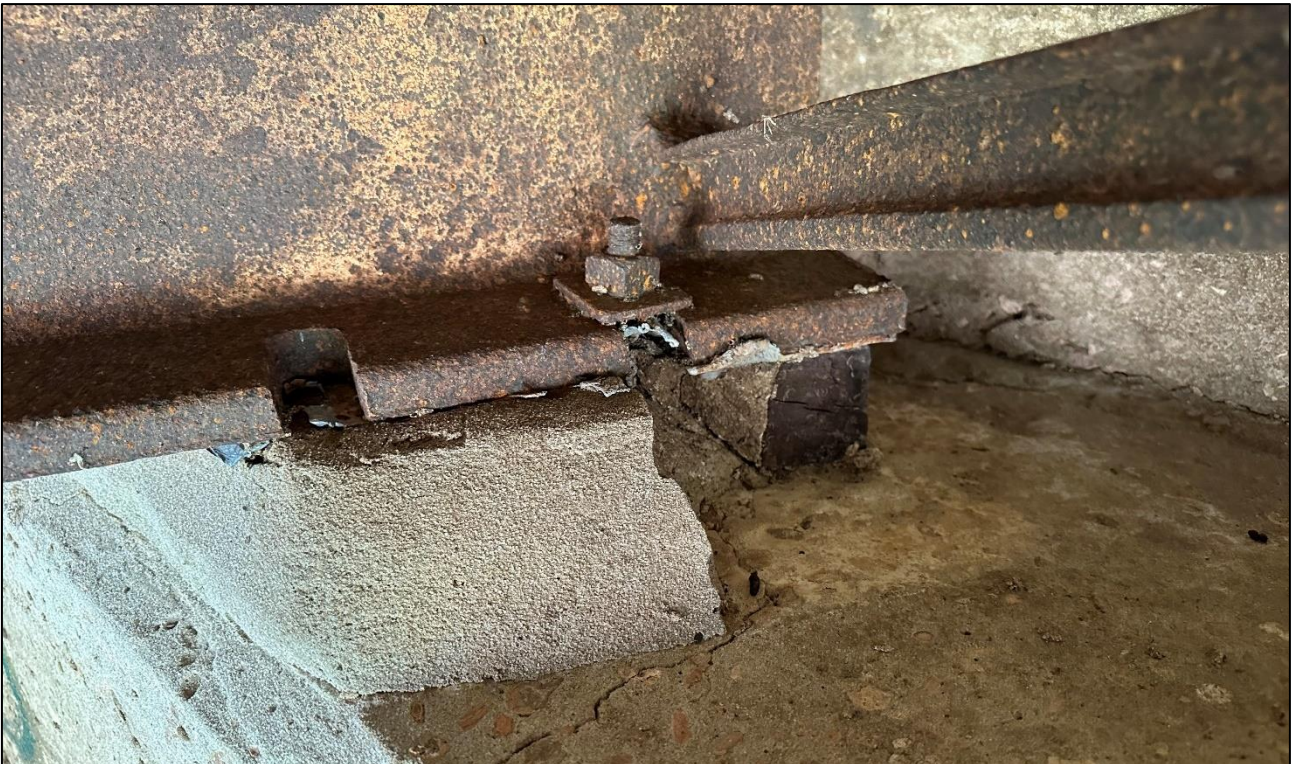
Grouted end bearings of the steel beams had been eroded due to historic cracking and floodwater activity. Lateral forces imposed by the flow of floodwater likely had contributed to further warping / rotation of the steel support beams due to lack of bridging / cross bracing – an item which was discussed within the initial report.

**Photo 4 - Fragments of grout beneath an end bearing had been washed away by floodwater**
