Renmark
Paringa
Council

BOAT RAMP

strategy

2021

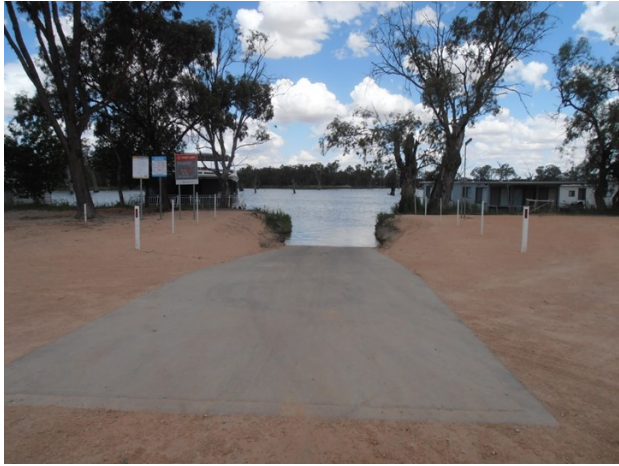
Location: Ral Ral Creek (Jane Eliza), Renmark

Tier 1 or 2:	1	
Registered BIA:	Yes	
Distance from Renmark Town Centre:	3.0km	
Distance from previous boat ramp:	5.0km (Patey Drive)	
Number of formal lanes:	1, 3 metres wide	
Material of ramp:	Concrete Ramp	
Details & Condition of Ramp:	<p>Grade: 14%</p> <p>This boat ramp is very narrow with failing concrete sides; some parts have been removed for the safety of users. The ramp floor is of concrete make and is well used by visitors and locals, however users find it difficult to tie up boats and get a level area that is suitable to load passengers and equipment. It does have a long continuing easy grade to the water.</p> <p>The ramp base itself is in fair condition. However the side walls are a combination of earth and concrete. The concrete parts are in very poor condition and can be quite challenging for users.</p>	
Car and Trailer parking available?	Yes, unsealed carpark with approximately 4 spaces

Are there any additional assets (e.g. pontoons/jetties)	No	
Does the parking meet the demand during peak periods?	No, parking is difficult during busy periods forcing people to park on roadways or on vegetated areas. Some users have had their vehicles block in by others	
Does the ramp meet the demand during peak periods?	The ramp suffices for normal use with generally small delays during peak periods. These delays would not be seen as significant, around 10 to 15 minutes.	
Are there any recent, ongoing or planned maintenance or upgrades?	No	
Suitability Rating:	Level 2 & 3	
Recommendations:	<p>Council consider this area for upgrades in the near future –looking at new complying ramps, pontoons, sealed car parking and sealing access roads.</p> <p>Upgrades here are being considered in the Jane Eliza Marina Master Plan. Improvement here would reduce demand on the Patey Drive infrastructure giving the township two complying boat ramp options.</p>

Estimated cost:	\$250,000

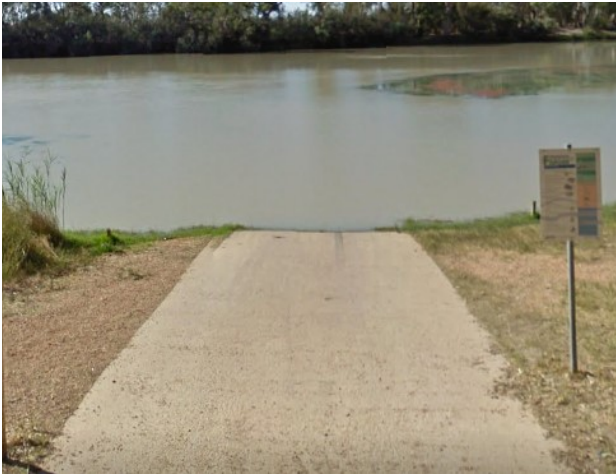
Location: Plush's Bend, Renmark

Tier 1 or 2:	1	
Registered BIA:	Yes	
Distance from Renmark Town Centre:	6.1km	
Distance from previous boat ramp:	8km (Patey Drive)	
Number of formal lanes:	1, 5 metres wide	
Material of ramp:	Concrete ramp	
Details & Condition of Ramp:	<p>Grade: 16%</p> <p>The ramp base is concrete and in fair condition.</p> <p>This boat ramp is very well supported by local residents and visitors. The ramp itself is only a concrete floor with no pontoons to assist in loading and unloading boats. It is generally considered to be a “good “ ramp for smaller craft. Traditionally it does not see a lot of larger wake type boats using this facility, however the demand may increase with upgrades.</p>	
Car and Trailer parking available?	Parking is available however unsatisfactory	
Are there any additional assets (e.g. pontoons/jetties)	No	
Does the parking meet the demand during peak periods?	<p>No, parking is difficult during busy periods forcing people to park on roadways or on vegetated areas. Some users have had their vehicles block in by others.</p> <p>Area is mainly constructed of natural materials it can get muddy when wet and trees around the designated parking area can cause some difficulty when reversing.</p>

Does the ramp meet the demand during peak periods?	The ramp suffices for normal use during all periods	
Are there any recent, ongoing or planned maintenance or upgrades?	Yes, parking area maintenance will be undertaken with the 18/19 ABP Project Upgrades	
Suitability Rating:	Level 2 & 3	
Other amenities available:	Toilets, camping area, sandbar picnic area.	
Recommendations:	A floating boarding pontoon would improve the experience at this facility – improved hard stand parking areas	
Estimated cost:	\$75,000

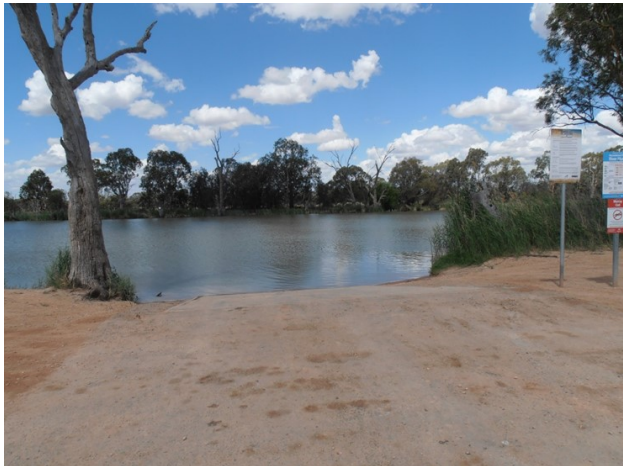
Location: Goolwa Street, Renmark North

Tier 1 or 2:	1	
Registered BIA:	Yes	
Distance from Renmark Town Centre:	6.8km	
Distance from previous boat ramp:	6.2km (Jane Eliza)	
Number of formal lanes:	1, 6 metres wide	
Material of ramp:	Concrete Ramp	
Details & Condition of Ramp:	<p>Grade: 17.5%</p> <p>Boat ramp is very popular manly with local users living in the rural area .It consist of a continuous flat grade concrete slab and is in good condition.</p> <p>There is limited space to tie up boats and load, unload passengers and equipment.</p>	
Car and Trailer parking available?	Yes, unsealed and unmarked area. Approximately 5 spaces	
Are there any additional assets (e.g. pontoons/jetties)	No	
Does the parking meet the demand during peak periods?	No, parking is difficult during busy periods forcing people to park on roadways or on vegetated areas.	
Does the ramp meet the demand during peak periods?	The ramp suffices for normal use during all periods with exceptions when special events like the Dinghy Derby are held.

Are there any recent, ongoing or planned maintenance or upgrades?	No	
Suitability Rating:	Level 2 & 3	
Other amenities available:	Nil	
Recommendations:	A floating boarding pontoon would improve the experience at this facility, constructing and bitumising road and carpark with additional bollards	
Estimated cost:	\$175,000

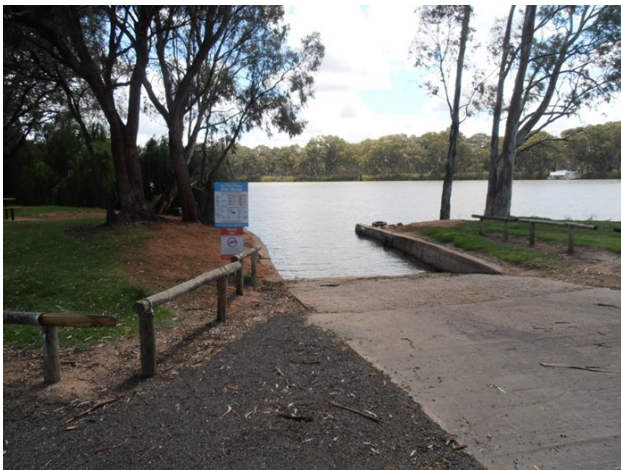
Location: Bert Dix Park, Paringa

Tier 1 or 2:	1	
Registered BIA:	Yes	
Distance from Renmark Town Centre:	4.1km	
Distance from previous boat ramp:	2.2km (Patey Drive)	
Number of formal lanes:	1, 4 metres wide	
Material of ramp:	Concrete	
Details & Condition of Ramp:	<p>Varying grades from 4% up to 17% at waters edge</p> <p>This boat ramp is the only formal concrete ramp available in Paringa. It does have some constructed sides that assist with loading and unloading boats. This ramp is satisfactory to the majority of users however the narrow approach and angle makes it difficult for larger boats. Upgrades to this ramp would improve the service for Paringa and reduce the demand on the Patey Drive ramp.</p> <p>The ramp concrete floor is in fair condition. Maintenance required around the side walls and mooring area</p>	
Car and Trailer parking available?	Parking area is sealed but unlined and limited due to shared area with park users.

Are there any additional assets (e.g. pontoons/jetties)	No	
Does the parking meet the demand during peak periods?	No	
Does the ramp meet the demand during peak periods?	The ramp suffices for normal use during all periods, upgrades would create more use.	
Are there any recent, ongoing or planned maintenance or upgrades?	No	
Suitability Rating:	Level 1, 2 & 3	
Other amenities available:	Toilets ,BBQ , playground, picnic area and shelters	
Recommendations:	A floating boarding pontoon would improve the experience at this facility along with bank stabilisation (completed with sheet piling)	
Estimated cost:	\$150,000

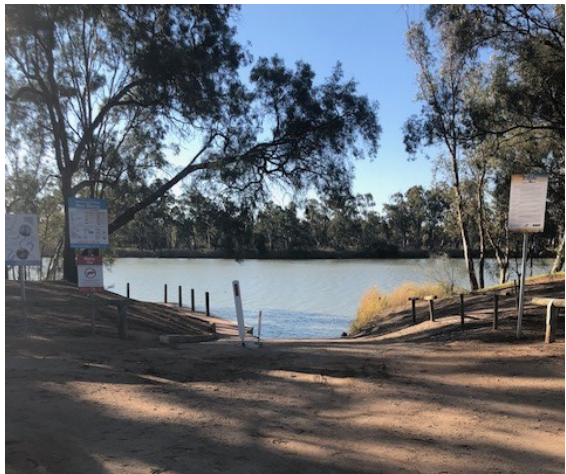
Location: SS Ellen Park, Lyrup

Tier 1 or 2:	1	
Registered BIA:	Yes	
Distance from Renmark Town Centre:	14.3km	
Distance from previous boat ramp:	16.8km (Plush’s Bend)	
Number of formal lanes:	1, 4 metres wide	
Material of ramp:	Concrete, rough finish	
Details & Condition of Ramp:	Grade: 16.6% average, waters edge 20.7% This boat ramp is the only formal concrete ramp available in the Lyrup. It has a constructed sheet pile walkway on the left hand side to assist with loading and unloading boats.	
Car and Trailer parking available?	Unsealed-no line marking	
Are there any additional assets (e.g. pontoons/jetties)	Yes, see above.	
Does the parking meet the demand during peak periods?	Yes	
Does the ramp meet the demand during peak periods?	The ramp suffices for normal use during all periods	
Are there any recent, ongoing or planned maintenance or upgrades?	No	
Suitability Rating:	Level 2 & 3	
Other amenities available:	Toilets ,BBQ , playground, picnic area

Recommendations:	A floating boarding pontoon would improve the experience at this facility. As this is the only ramp in the area consideration should be given to widening the existing one.	
Estimated cost:	\$150,000

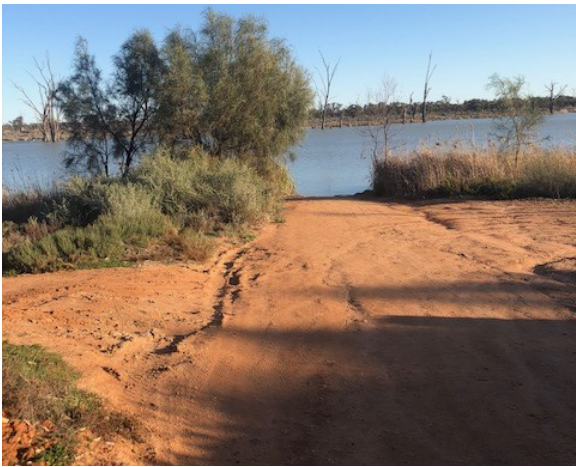
Location: Mundic Creek, Paringa

Tier 1 or 2:	2	
Registered BIA:	No	
Distance from Renmark Town Centre:	4.7km	
Distance from previous boat ramp:	1.6km (Bert Dix Park)	
Number of formal lanes:	1, 3 metres wide	
Material of ramp:	Non constructed earth	
Details & Condition of Ramp:	Grade: 8% (approximately) Earth ramp cut through levy bank, dry weather only. This is an informal ramp only, upgrades may increase the use of it. This ramp is for dry weather use only and in poor condition access ramp.	
Car and Trailer parking available?	Natural earth material, no formal recognition to parking	
Are there any additional assets (e.g. pontoons/jetties)	No	
Does the parking meet the demand during peak periods?	No, no formal recognition of parking	
Does the ramp meet the demand during peak periods?	The ramp suffices for normal use during all periods	
Are there any recent, ongoing or planned maintenance or upgrades?	No

Suitability Rating:	Level 3	
Other amenities available:	Nil	
Recommendations:	There are no formal boat ramps to provide access to the Mundic/Pike Creek System. Council could consider placing a prebuilt concrete ramp (slab only) and proving a sheeted access road and parking area	
Estimated cost:	\$50,000

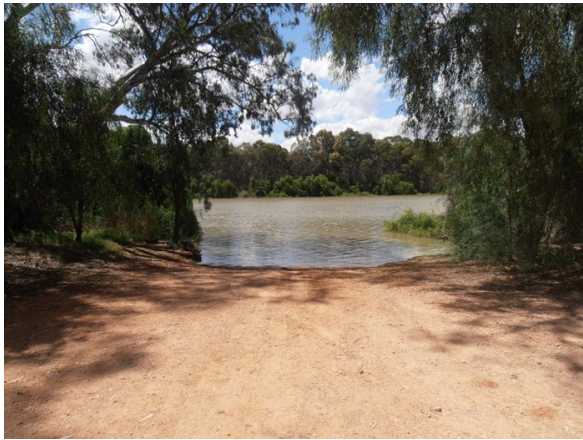
Location: Lock 5 Marina, Paringa

Tier 1 or 2:	2	
Registered BIA:	No	
Distance from Renmark Town Centre:	5km	
Distance from previous boat ramp:	1km (Bert Dix Park)	
Number of formal lanes:	1, 4 metres wide	
Material of ramp:	Road Base material	
Details & Condition of Ramp:	<p>Grade: 16.5%</p> <p>This boat ramp is used by houseboat hire operators and a few local users it is easy to use with good grades. The ramp is in fair condition and meets the needs of the community. There is a choice of Bert Dix Park a short distance away.</p>	
Car and Trailer parking available?	Yes, unsealed-no line marking	
Are there any additional assets (e.g. pontoons/jetties)	No	
Does the parking meet the demand during peak periods?	No	
Does the ramp meet the demand during peak periods?	Yes	
Are there any recent, ongoing or planned maintenance or upgrades?	No	
Suitability Rating:	Level 3	
Other amenities available:	Nil	
Recommendations:	Council maintain ramp at current standard

Estimated cost:	Not applicable

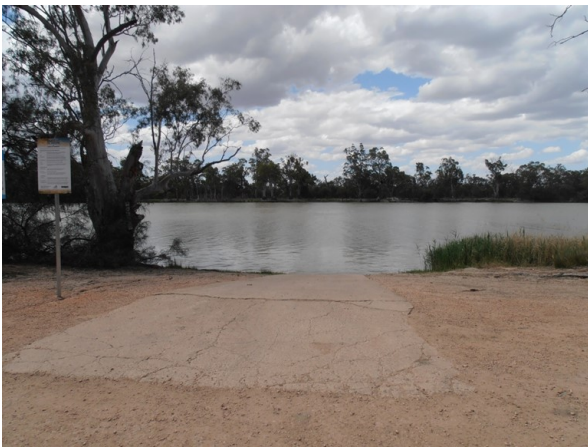
Location: Headings Cliff, Murtho

Tier 1 or 2:	1	
Registered BIA:	Yes	
Distance from Renmark Town Centre:	20.3km	
Distance from previous boat ramp:	17.2km (Bert Dix Park)	
Number of formal lanes:	1, 3 metres wide	
Material of ramp:	Concrete Ramp, slab only	
Details & Condition of Ramp:	Grade: 18% The concrete ramp is in good condition. Boarding and loading the boats can be difficult. This ramp is in the Murtho Forest conservation park and any alterations would require approval from State Government.	
Car and Trailer parking available?	Yes, unsealed and no line marking	
Are there any additional assets (e.g. pontoons/jetties)	No	
Does the parking meet the demand during peak periods?	Yes	
Does the ramp meet the demand during peak periods?	Yes	
Are there any recent, ongoing or planned maintenance or upgrades?	No	
Suitability Rating:	Level 1, 2 & 3	
Other amenities available:	Camping area	
Recommendations:	A floating boarding pontoon would improve the experience at this facility

Estimated cost:	\$50,000

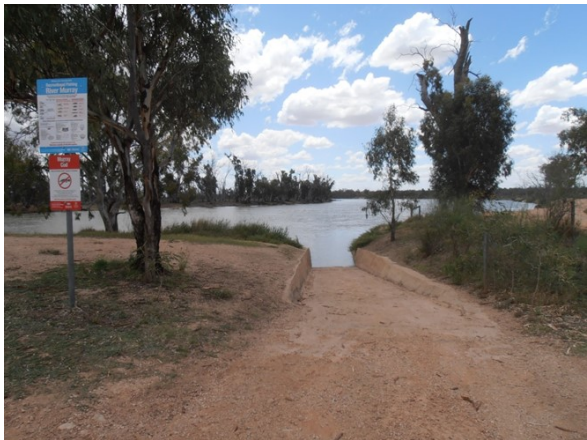
Location: Lock 6, Murtho

Tier 1 or 2:	1	
Registered BIA:	Yes	
Distance from Renmark Town Centre:	30.1km	
Distance from previous boat ramp:	12.1km (Wilkadene)	
Number of formal lanes:	1, 3 metres wide	
Material of ramp:	Concrete	
Details & Condition of Ramp:	Grade: 18% (approximately) All weather access, the ramp is in fair condition but only suitable for small boats. This ramp is very narrow with steep concrete sides and can be difficult to use. It can be difficult to find suitable riverbank to tie boats up to when loading and unloading.	
Car and Trailer parking available?	Yes, informal carpark with approximately 3 spaces	
Are there any additional assets (e.g. pontoons/jetties)	No	
Does the parking meet the demand during peak periods?	Yes	
Does the ramp meet the demand during peak periods?	Yes	
Are there any recent, ongoing or planned maintenance or upgrades?	No	
Suitability Rating:	Level 3

Other amenities available:	Nil	
Recommendations:	A floating boarding pontoon would improve the experience at this facility as would increasing width to 5 metres.	
Estimated cost:	\$100,000

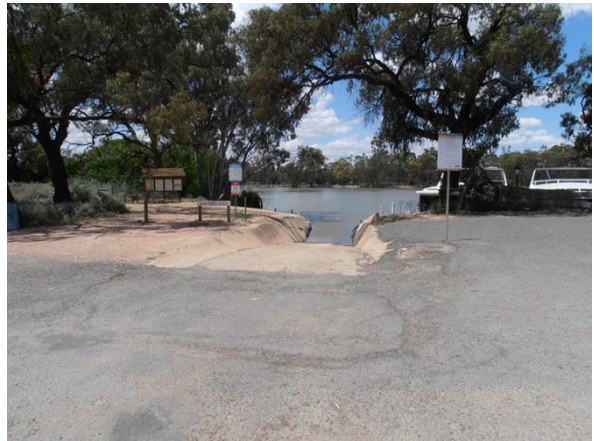
Location: Custom's House, Murtho

Tier 1 or 2:	1	
Registered BIA:	Yes	
Distance from Renmark Town Centre:	34.7km	
Distance from previous boat ramp:	13km (Lock 6)	
Number of formal lanes:	1, 3 metres wide	
Material of ramp:	Concrete base and walls	
Details & Condition of Ramp:	<p>Grade: 18%</p> <p>Boat ramp is a narrow concrete structure with concrete side walls. There is a small landing platform for loading and unloading boats. This ramp does cater for larger wake and ski boats however there is a high risk of damage to the boat.</p> <p>The ramp concrete floor is starting to wear and has some tripping hazards. Although there is other infrastructure such as a small wharf, it is in poor condition.</p>	
Car and Trailer parking available?	Yes, sealed and line marked.	
Are there any additional assets (e.g. pontoons/jetties)	Yes, small pontoon	
Does the parking meet the demand during peak periods?	Yes	
Does the ramp meet the demand during peak periods?	Yes, the ramp suffices for normal use during all periods

Are there any recent, ongoing or planned maintenance or upgrades?	No	
Suitability Rating:	Level 2 & 3	
Other amenities available:	Toilets, picnic area, fuel, store and camping	
Recommendations:	Improve the walkway, widen ramp and install a floating pontoon.	
Estimated cost:	\$150,000

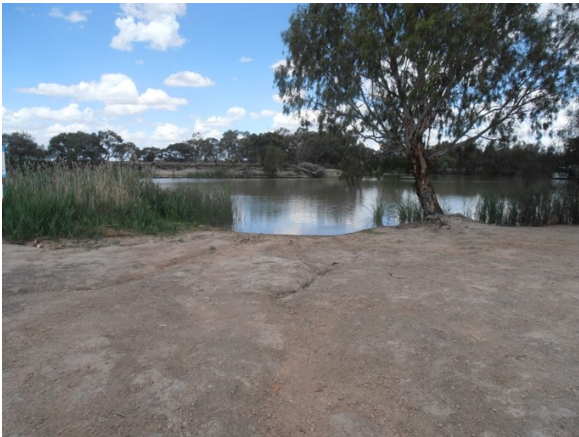
Location: Warrego Street, Renmark North

Tier 1 or 2:	2	
Registered BIA:	No	
Distance from Renmark Town Centre:	10km	
Distance from previous boat ramp:	5.8km (Goolwa Street)	
Number of formal lanes:	1, 4 metres wide	
Material of ramp:	Unsealed	
Details & Condition of Ramp:	<p>Grade: 12.6%</p> <p>This is a very basic informal ramp not recognised as Council’s property or responsibility .Access is via RIT property with a small ribbon of land at the waters edge under the care of DEW. This area is accessible during dry weather only.</p> <p>The access ramp is a non constructed and of natural material, 4x4 would be recommended. Very poor condition.</p>	
Car and Trailer parking available?	No formal area, natural formed	
Are there any additional assets (e.g. pontoons/jetties)	No	
Does the parking meet the demand during peak periods?	Not applicable	
Does the ramp meet the demand during peak periods?	Not applicable

Are there any recent, ongoing or planned maintenance or upgrades?	Not applicable	
Suitability Rating:	Level 3	
Other amenities available:	No	
Recommendations:	Council do not recognise this as a boat ramp.	
Estimated cost:	Not applicable

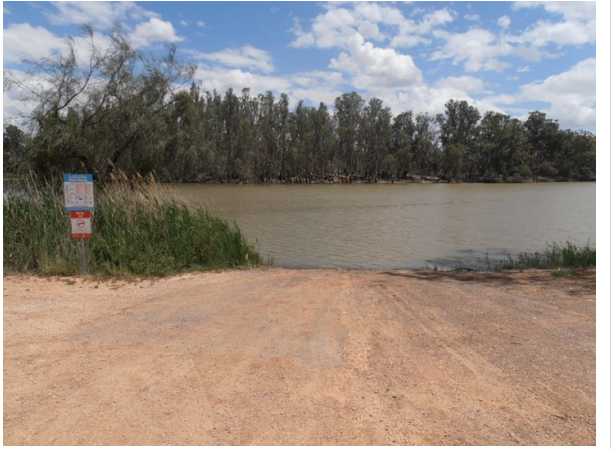
Location: Wilkadene, Murtho

Tier 1 or 2:	2	
Registered BIA:	No	
Distance from Renmark Town Centre:	20.3km	
Distance from previous boat ramp:	8km (Headings Cliff)	
Number of formal lanes:	1, 4 metres wide	
Material of ramp:	Predominantly natural material with some road base visible.	
Details & Condition of Ramp:	<p>Grade: 15%</p> <p>This boat ramp is not recognised as a Council asset and is on DEW land. It is very soft and users quite often get bogged. Some road base material has been placed from time to time by others. Ramp is in poor condition that can be hazardous for users who are unfamiliar with it.</p>	
Car and Trailer parking available?	No	
Are there any additional assets (e.g. pontoons/jetties)	No	
Does the parking meet the demand during peak periods?	No	
Does the ramp meet the demand during peak periods?	No	
Are there any recent, ongoing or planned maintenance or upgrades?	No	
Suitability Rating:	Level 3

Other amenities available:	Nearby Tourist Attraction, Woolshed Brewery	
Recommendations:	That Council does not accept responsibility for this ramp	
Estimated cost:	Not applicable
