Level 2 Structure Condition Report (Suggested Form)	Form L2-1
---	------------------

Structure ID	BR001	Road Name	Twentyfirst Street
Bridge Name	Twentyfirst Street Bridge	Road Number	-
Crossing (road or stream)	Stream	Road Class	Local
Structure Type	Road Bridge	Locality/Suburb	Renmark, SA 5341
Construction Type	Abutment, piers, support beams and concrete deck	Map Number	-
		Ref #	-
Construction Material	Concrete	Latitude	-34.173949
Date of Construction	1960	Longitude	140.728693
Date of Inspection	18/05/2023	Local Authority	Renmark Paringa Council

Twentyfirst St Bridge, Renmark

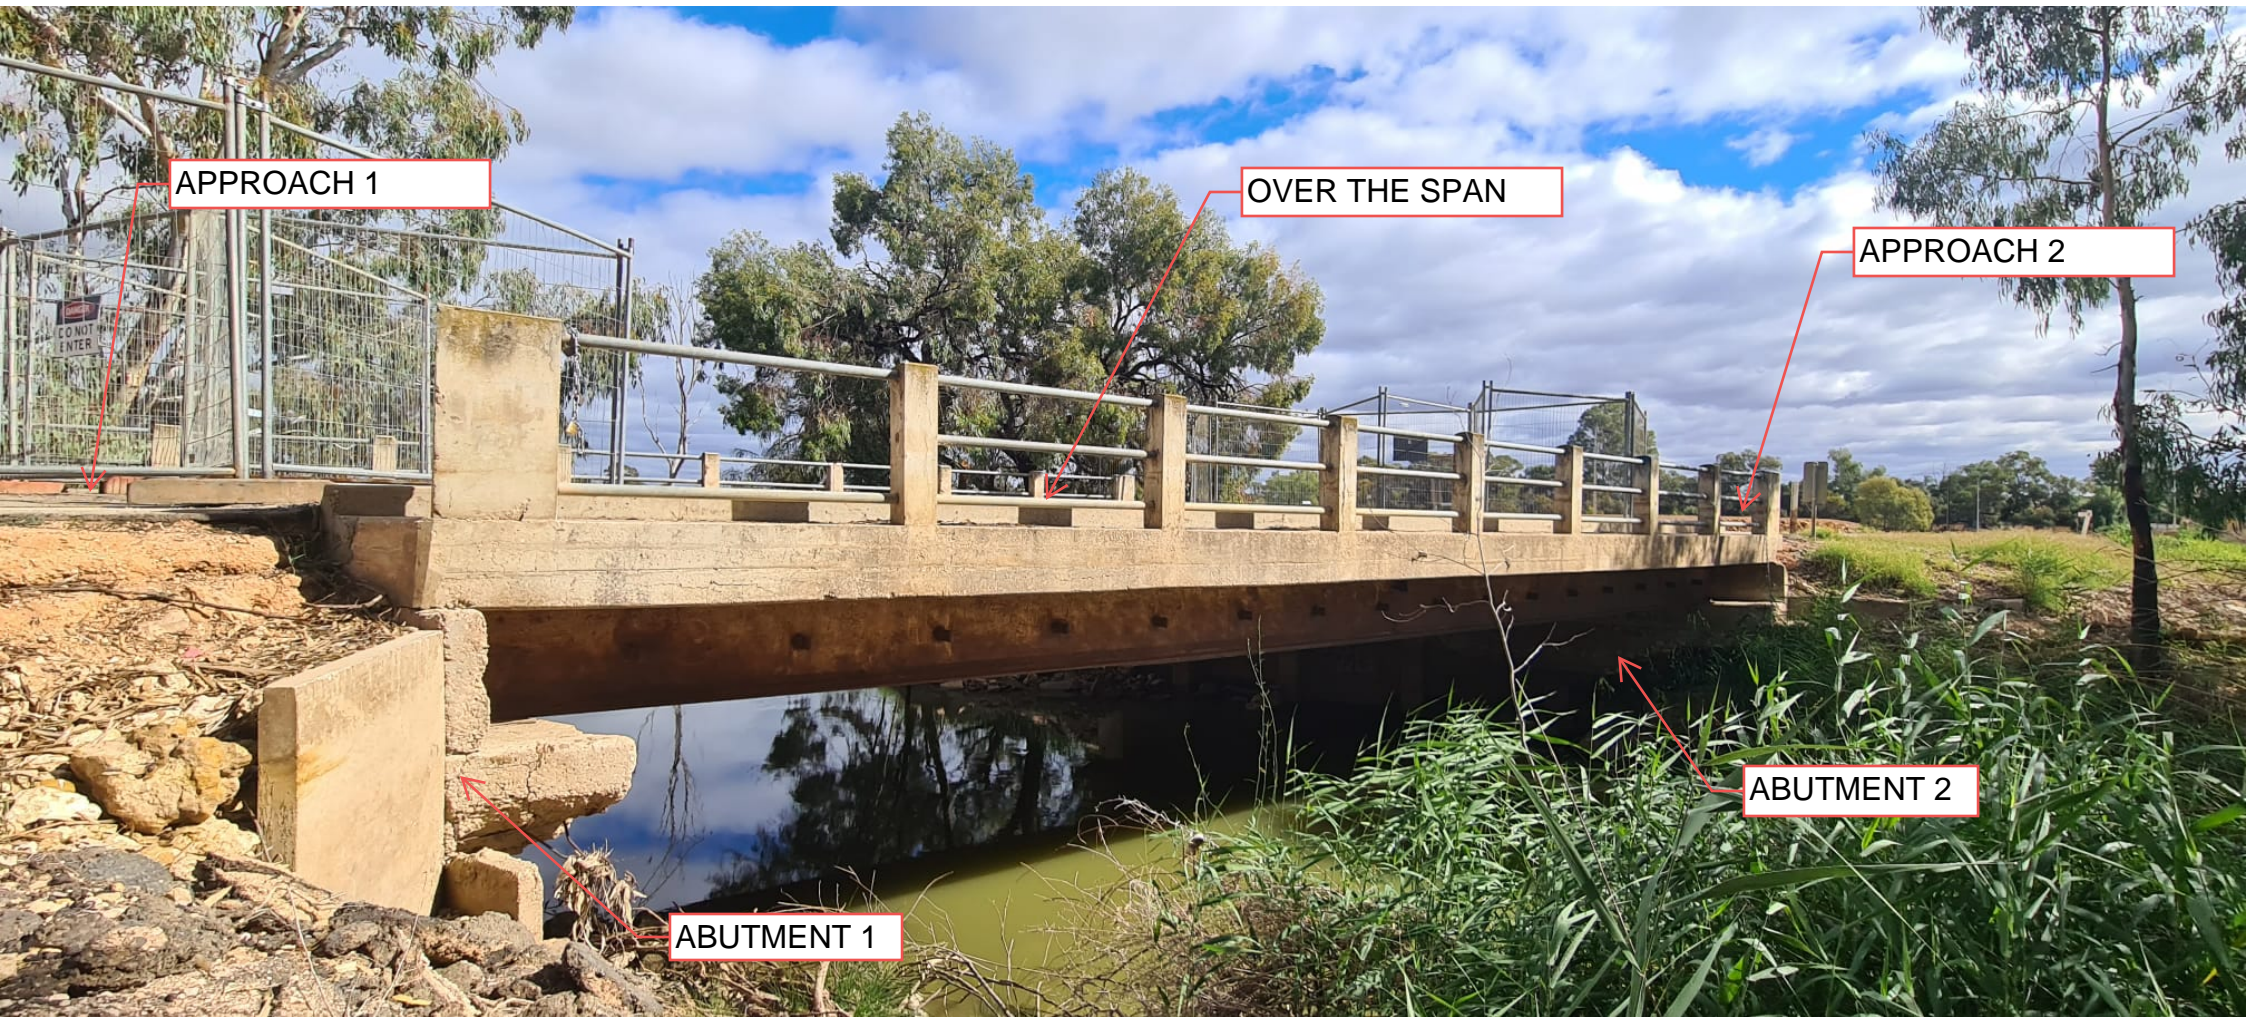
Approach 1

O		AP	1	RD	1	O	Each	1	2	<input checked="" type="checkbox"/>				1	TMK (Post-Flood) - Floodwaters had caused erosion to base course and subgrade layers beneath the road surface at the abutments – causing loss of portions of the road surface. Tonkin - Road scour and more severe closer to the joint/abutment. Pavement base course and subgrade layers eroded at the road shoulders. Need reinstating.
O		AP	1	BR	2	S	Lm	1	2	<input checked="" type="checkbox"/>				1	TMK (Pre-Flood) - Hand rails on both external perimeters of the bridge were observed during TMK's onsite investigation to have visually evident deterioration and cracking, due to the expansion caused by corrosion of the internal reinforcement of the concrete post. It was observed that the hand rail system was not structurally adequate to serve as a vehicular impact barrier, rather just a pedestrian access perimeter barrier. Tonkin - Signs of severe concrete cracking and deterioration. Steel sections not held together very effectively. Barrier deemed inadequate to absorb significant vehicle impact. Corrosion of the internal reinforcement in the concrete posts have caused cracking at the edge of the deck. A steel section is missing between the first two concrete posts.
